# e-ASK Demonstration Fixture

## Operation Instructions

### Using this Guide

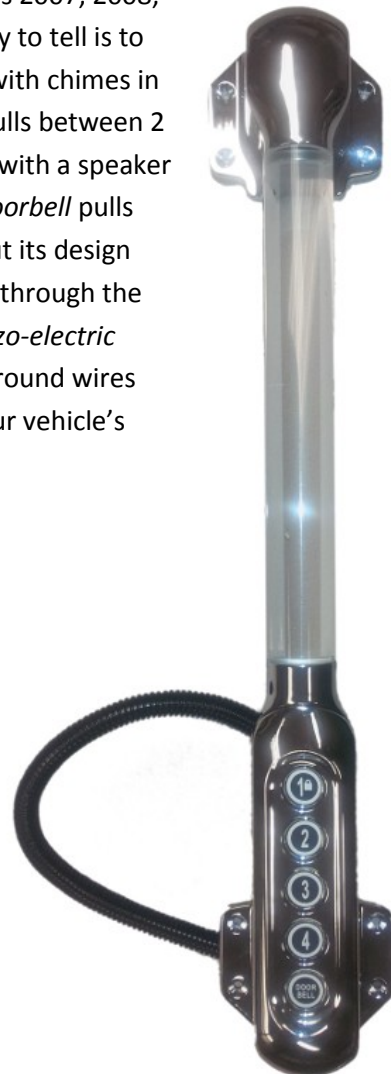
The vehicles that have shown this kind of failure were model years 2007, 2008, and in rare cases 2009. Later models do not need this fix. The way to tell is to find your vehicle's doorbell fixture. If it is a *chime-style doorbell* with chimes in the fixture, then you will need this fix. The *chime-style doorbell* pulls between 2 and 10 Amps through the keypad. If it is a *piezo-electric doorbell* with a speaker instead of chimes, you may still need this fix. The *piezo-electric doorbell* pulls less than 500mA through the keypad during normal operation, but its design makes it susceptible to passing voltage spikes from other devices through the signal wire to the keypad, resulting in similar damage. If your *piezo-electric doorbell* has a large capacitor soldered between the power and ground wires (not the signal wire) near where they enter the doorbell, then your vehicle's doorbell design is safe and this fix is not necessary.

The wire connecting the doorbell to the keypad must be traced to ensure that there is not already a relay in place. If there is already a relay in the doorbell control wire, and the doorbell system has failed, then the relay may be faulty and should be replaced instead of, or in addition to, the keypad.

The best place to start is at the doorbell. If the doorbell cannot be found, contact the manufacturer of the RV to determine where the likely mounting locations are. If the doorbell is still functional, triggering the doorbell can aid in locating it, but each time the doorbell is activated without this problem fixed greatly reduces the life expectancy of the keypad.

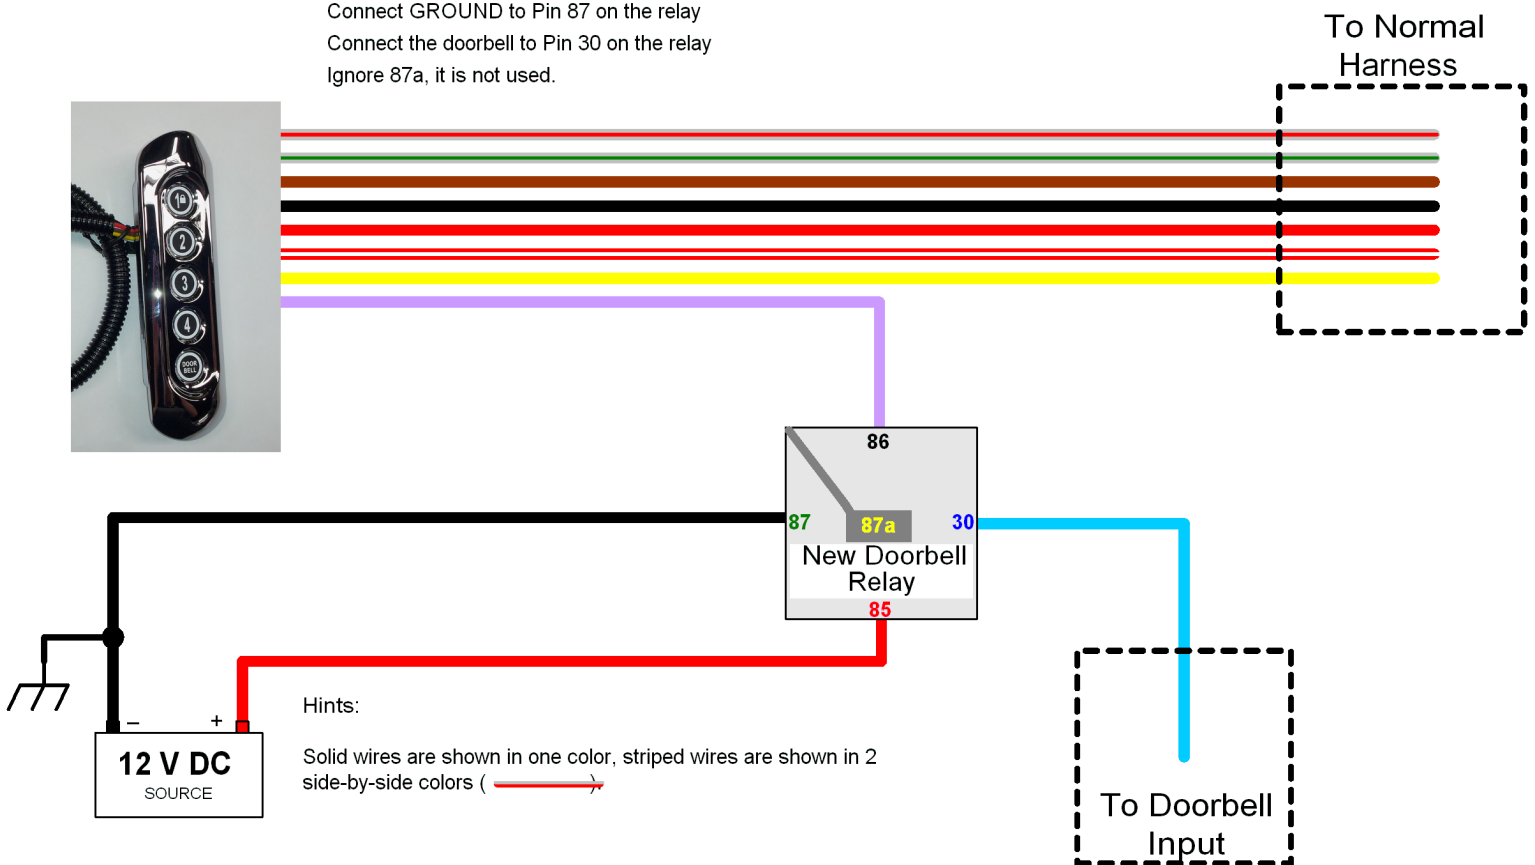
## Wiring Diagram - Doorbell Keypad Doorbell Output

Some Monaco RVs (includes *Monaco, Holiday Rambler, Beaver, and Safari*) with the Doorbell version of the TriMark e-GRAB Handle or the embedded e-PAD have the doorbell button of the keypad directly connected to the doorbell device inside the RV. The type of doorbell being controlled by the keypad requires much more than the 500mA that the keypad is rated for, and will eventually destroy the keypad. To prevent this from happening, or to retrofit a replacement so that it does not happen again, a relay must be installed to electrically isolate the keypad from the doorbell.

*NOTE: Colors shown below are based on the colors of the wires coming out of the keypad based on production in 2010. Your colors may vary depending on Monaco's coach harness and some color changes in TriMark production between 2007 and 2010. The doorbell signal wire will be the only wire that is routed from the keypad towards the doorbell.*

1. Cut the wire connecting the keypad to the doorbell near an area that can conveniently mount a relay, such as near a hidden wall or electrical cabinet.
2. Run a +12V and a Ground wire to the location where the relay will be mounted.
3. Wire the relay according to the schematic below.
4. Test the doorbell for proper operation with the keypad.

Notes: Cut the purple wire from the rest of the harness and route it to Pin 86 on the new relay  
Connect +12V to Pin 85 on the relay  
Connect GROUND to Pin 87 on the relay  
Connect the doorbell to Pin 30 on the relay  
Ignore 87a, it is not used.
